ON-SITE AIR BAG INVESTIGATION

CASE NO. - 94-09

LOCATION - [REDACTED] KENTUCKY

The front left of the Corsica impacted the front left of the C-1500 pickup. The CDCs were determined to be: 12-FLAE-7 for the Corsica and 12-FYEW-5 for the C-1500. The CRASHPC reconstruction program, damage and trajectory algorithm, was used on the impact (highest severity) to the Corsica. The Total, Longitudinal, and Lateral Delta Vs are respectively: 35 k.p.h. (22 m.p.h.), -35 k.p.h. (-22 m.p.h.), and +0 k.p.h. (+0 m.p.h.).

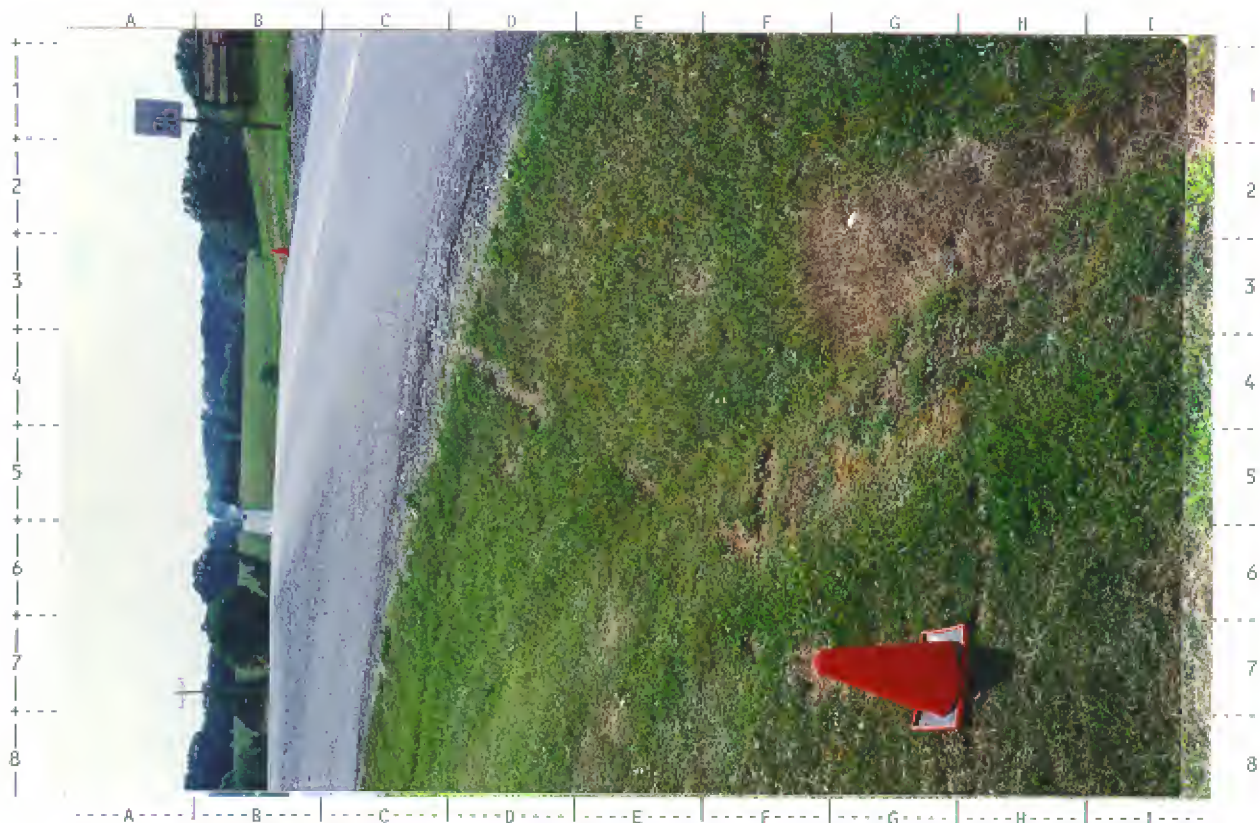
25 -- Westward view of 1988 Chevrolet C-1500 pickup's final rest position; NOTE: radiator grass kill & gouge in grass from LF rim

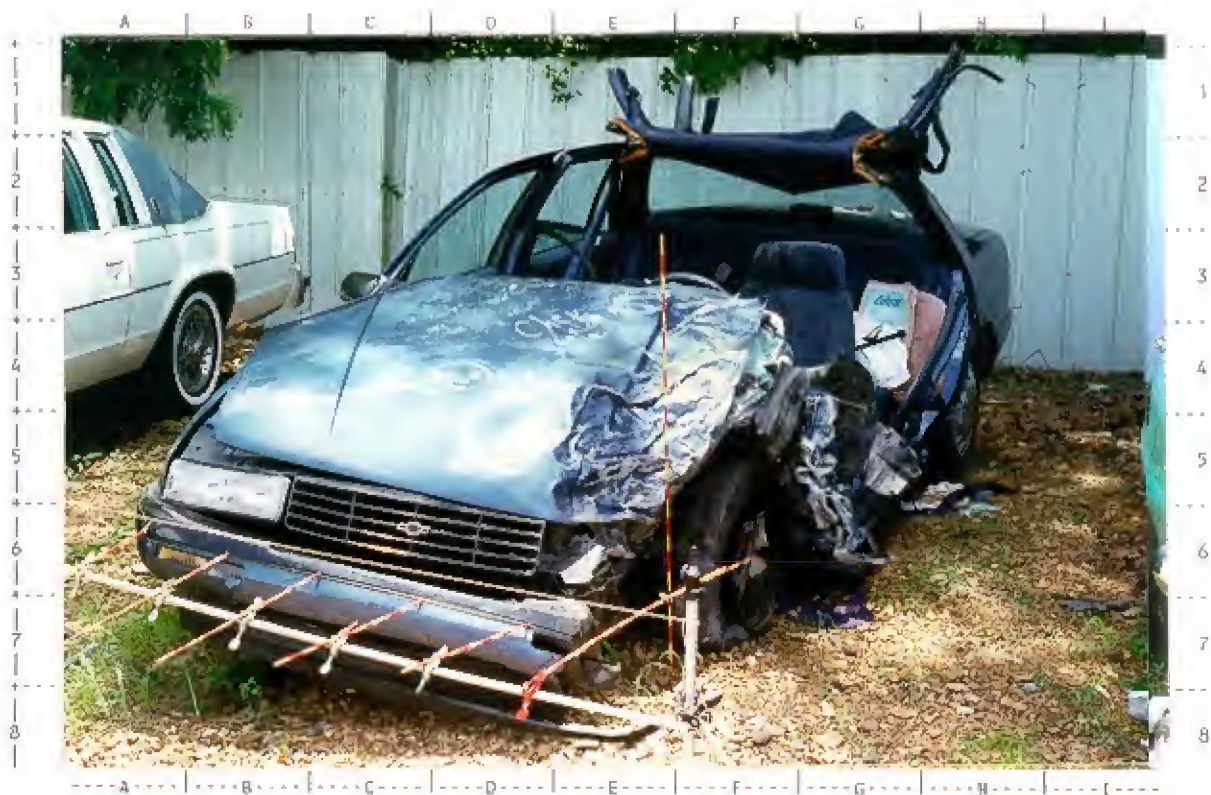
31 -- Front left view of 1991 Corsica's front left damage with contour gauge present; NOTE: peeled-back roof and cut L A- & B-pillars

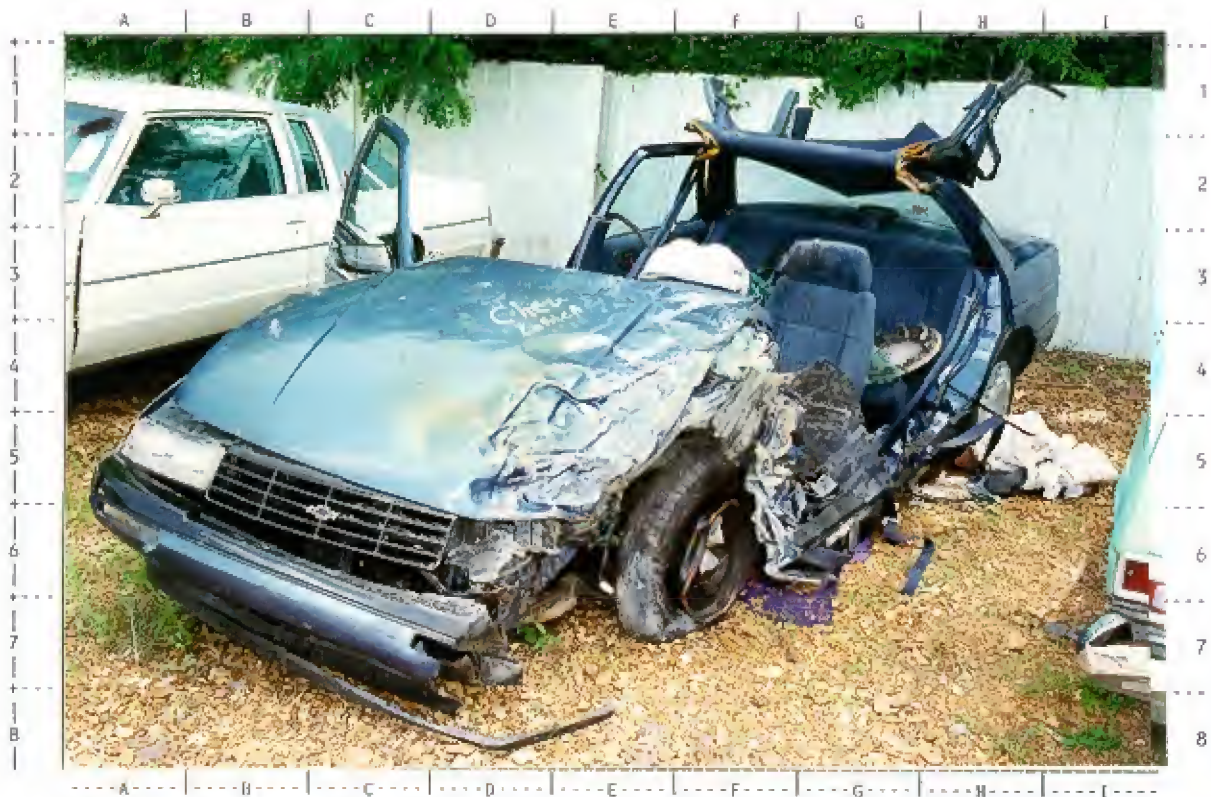
32 -- Front left (45 degree angle) view of 1991 Corsica's front left damage without contour gauge present; NOTE: roof & cut pillars

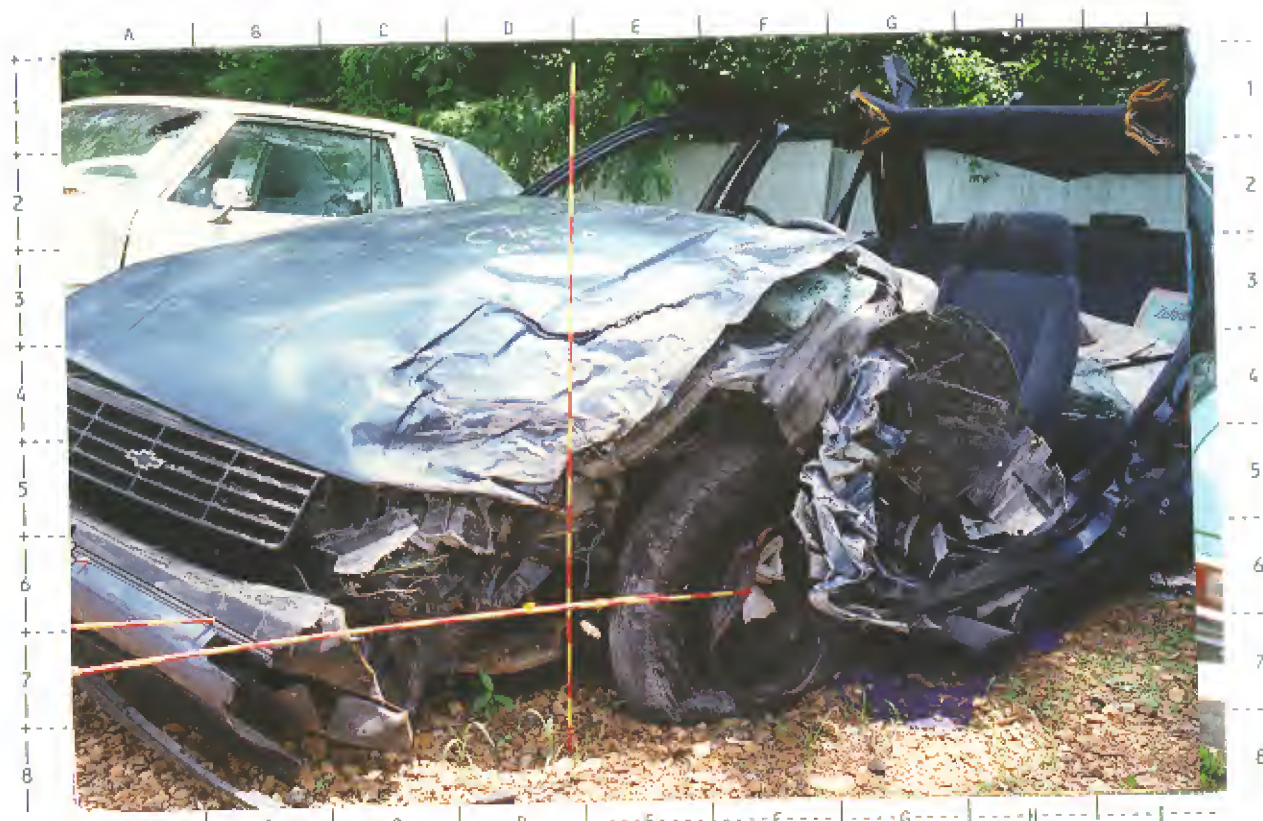
33 -- Front left (45 degree angle) view of direct damage to 1991 Chevrolet Corsica; NOTE: peeled-back roof and cut I A- & B-pillars

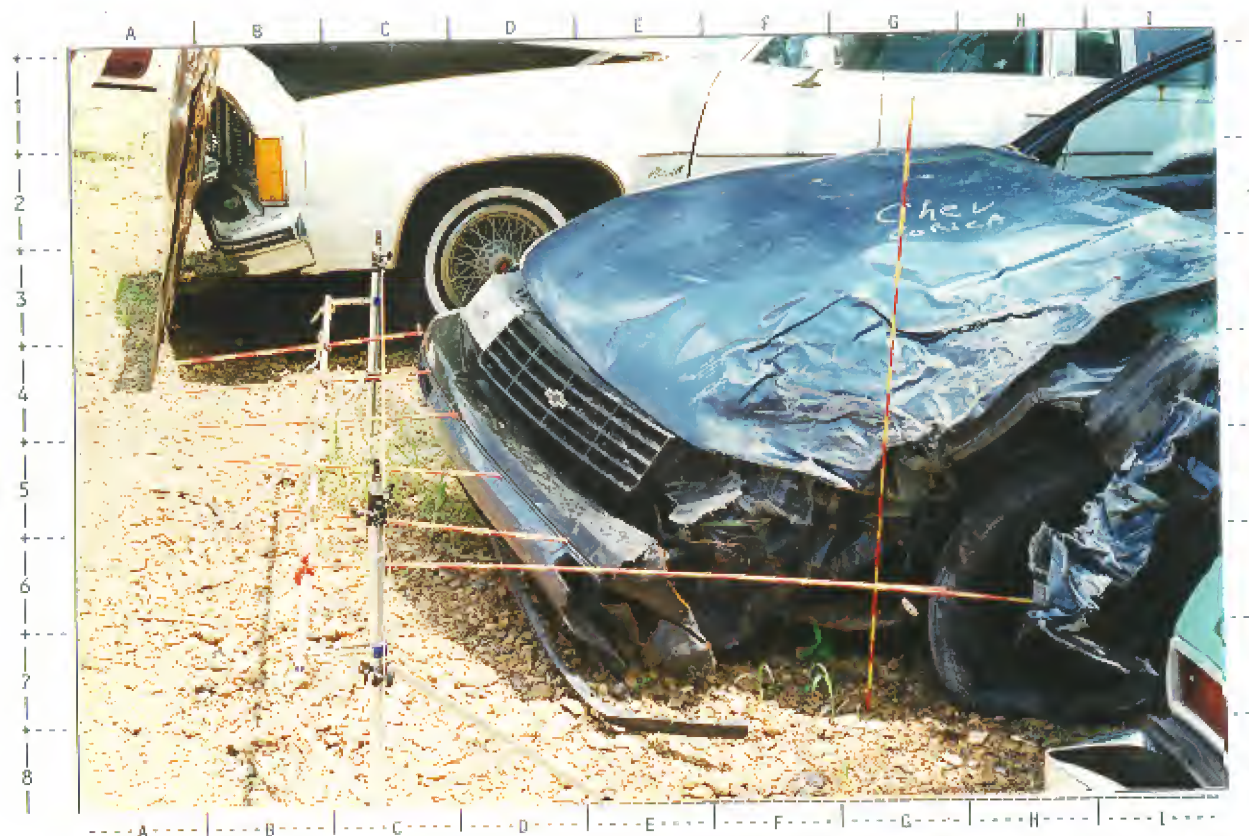
34 -- Front reference line viewed from left showing frontal damage to 1991 Chevrolet Corsica; NOTE: maximum crush and vertical rod

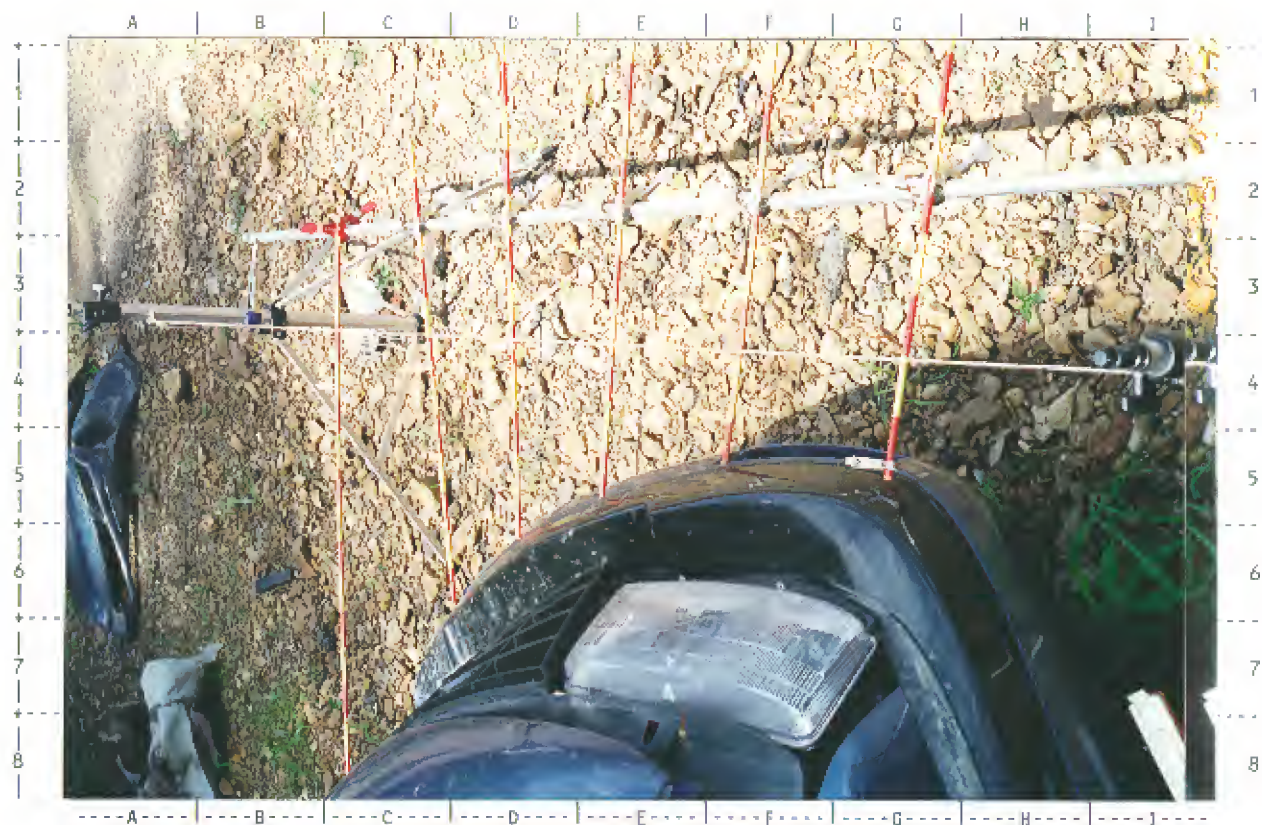
35 -- Front reference line viewed from right showing frontal damage to 1991 Chevrolet Corsica; NOTE: induced damage along front

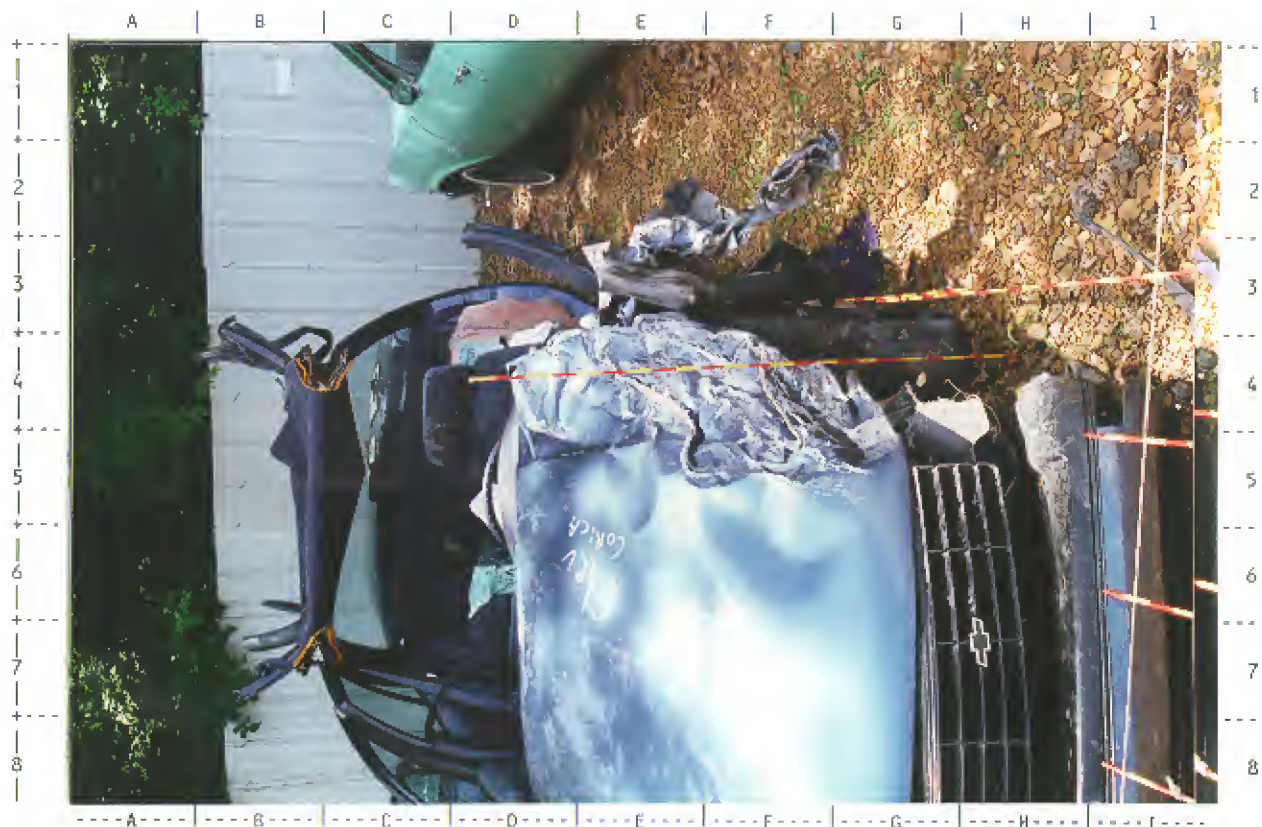
36 -- View along 1991 Chevrolet Corsica's left side showing extensive FL corner damage; NOTE: maximum crush & vertical reference rod

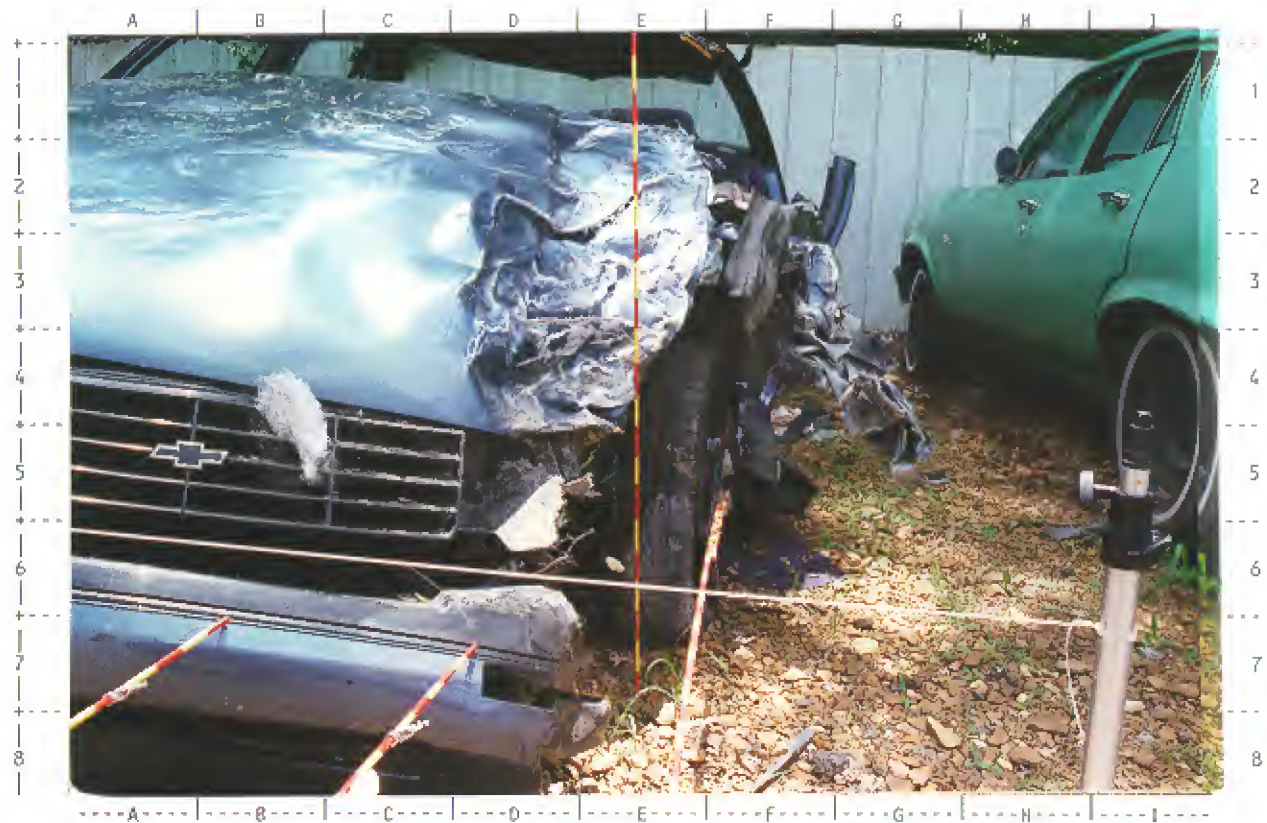
37 -- Bumper level view along 1991 Chevrolet Corsica's left side showing extensive FL corner damage, maximum crush, & reference rod

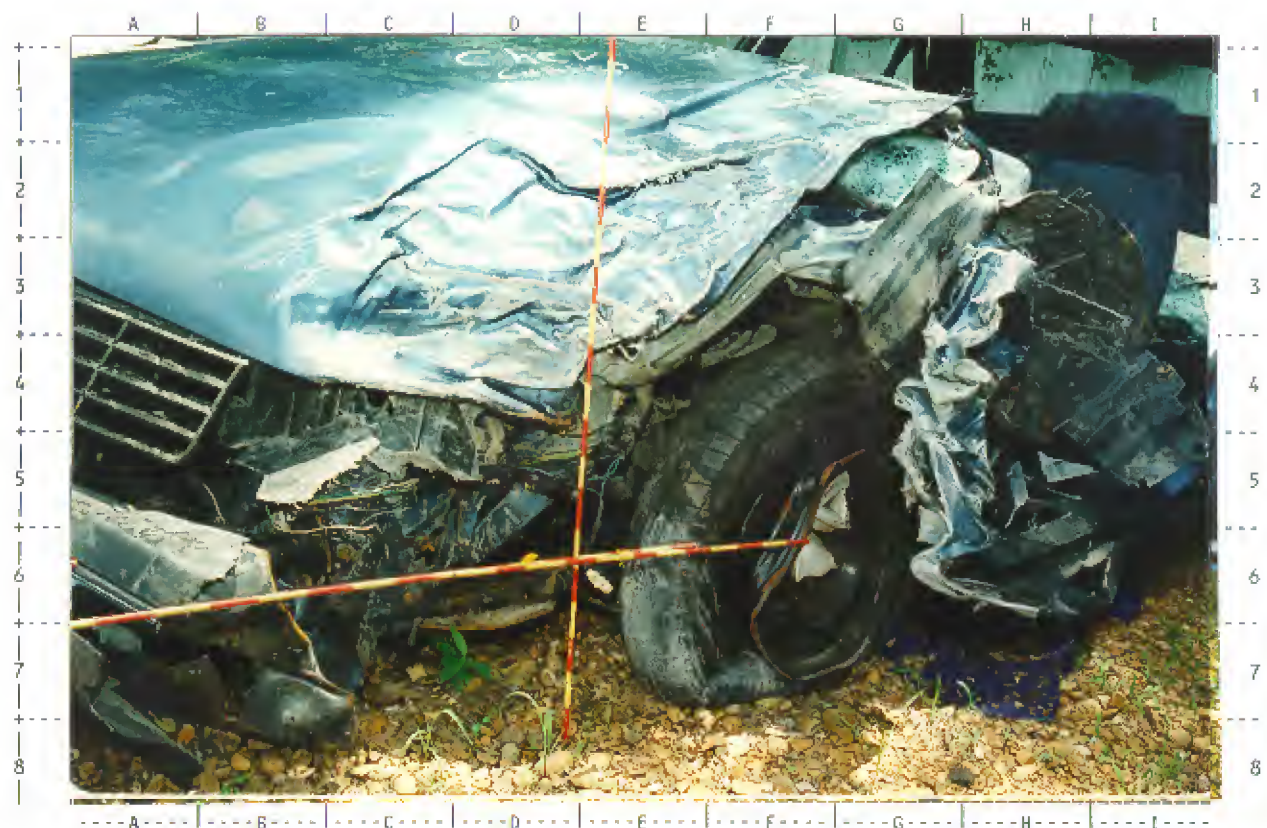
38 -- Close-up front left (45 degree angle) view of 1991 Chevrolet Corsica's damage to left front tire and rim

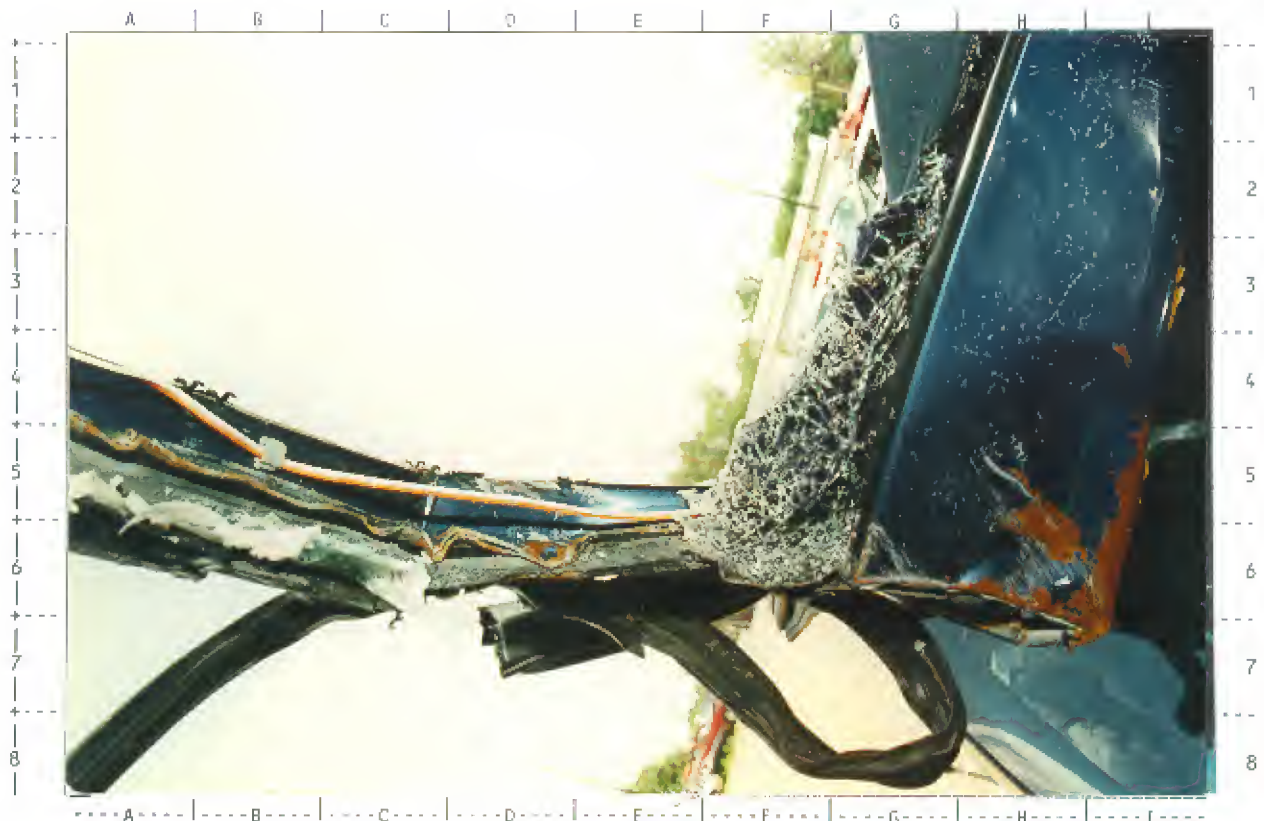
43 -- Close-up of direct damage to '91 Chevrolet Corsica's left A-pillar and roof corner--viewed from back

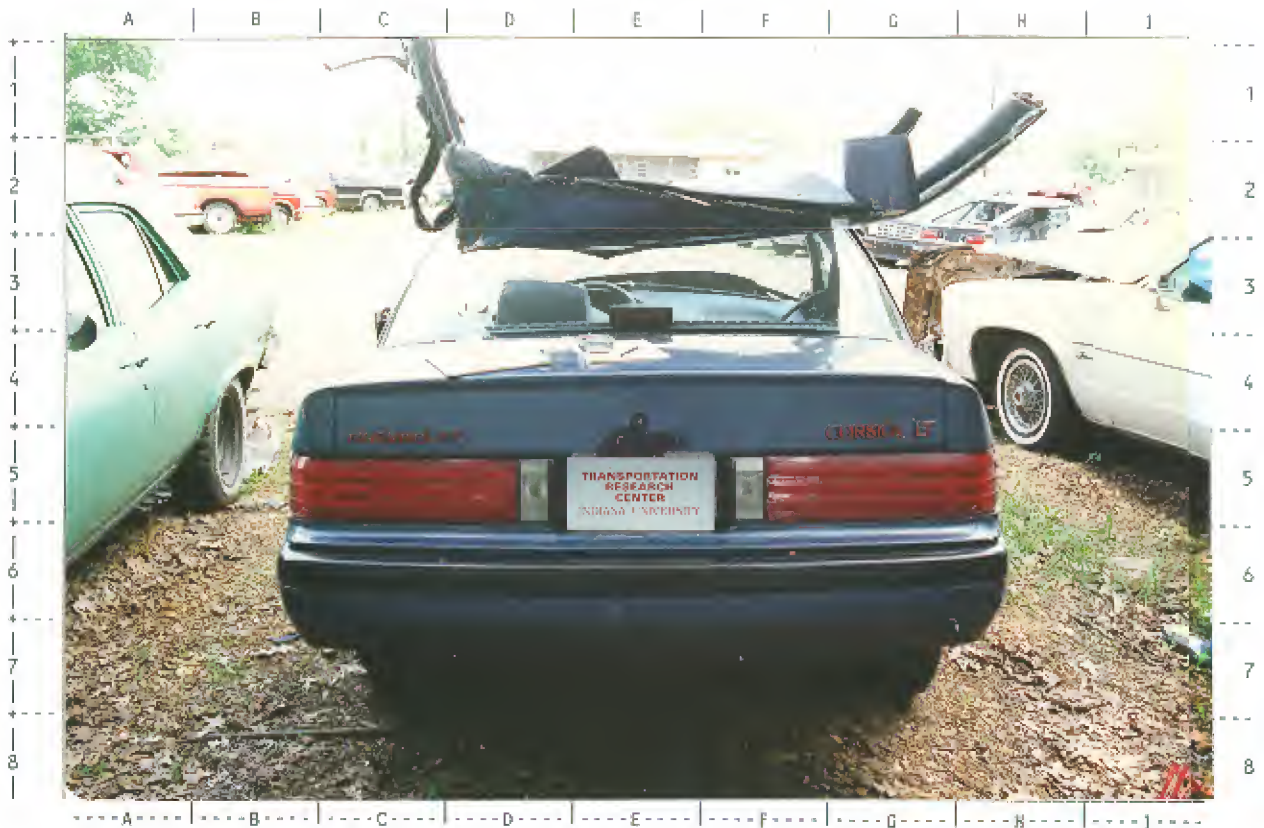
44 -- Back view of 1991 Chevrolet Corsica's undamaged back

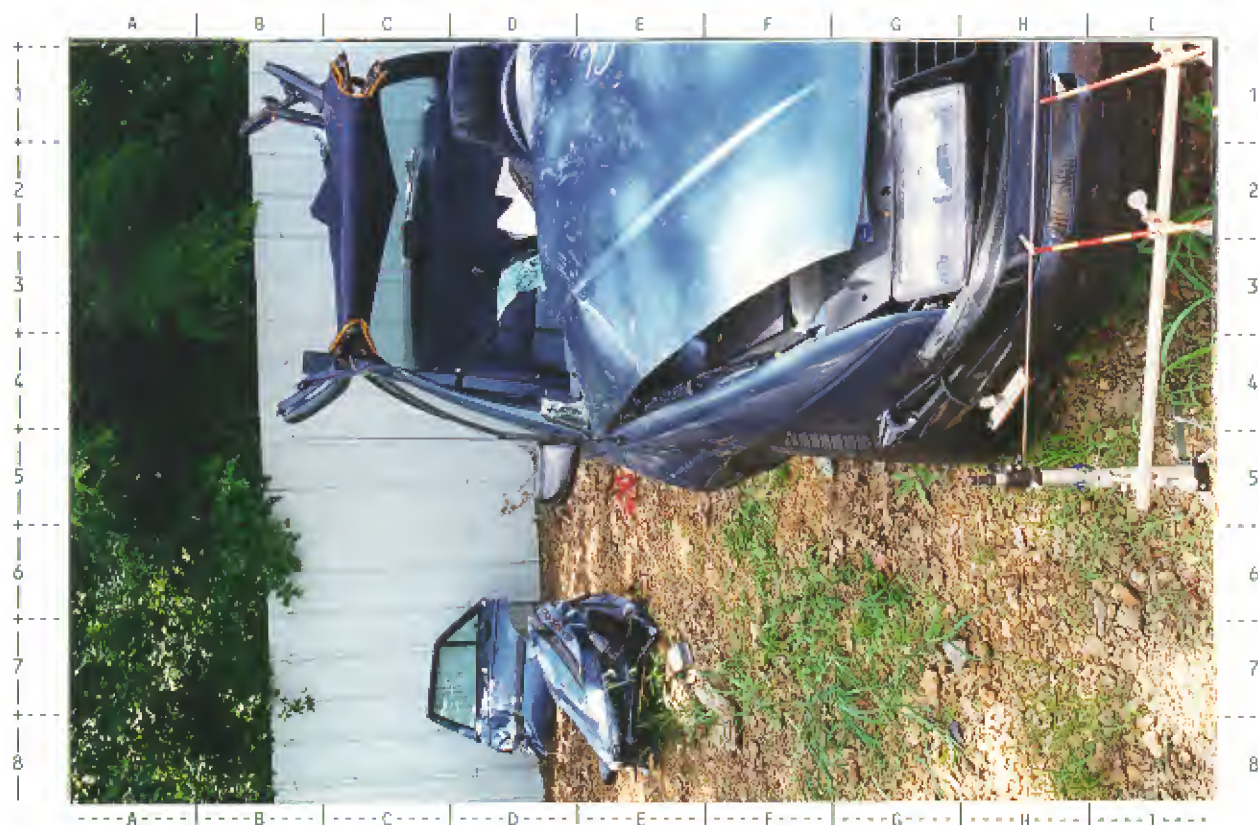
47 -- Right side reference line viewed from front showing induced damage to 1991 Chevrolet Corsica's RF fender and front right corner

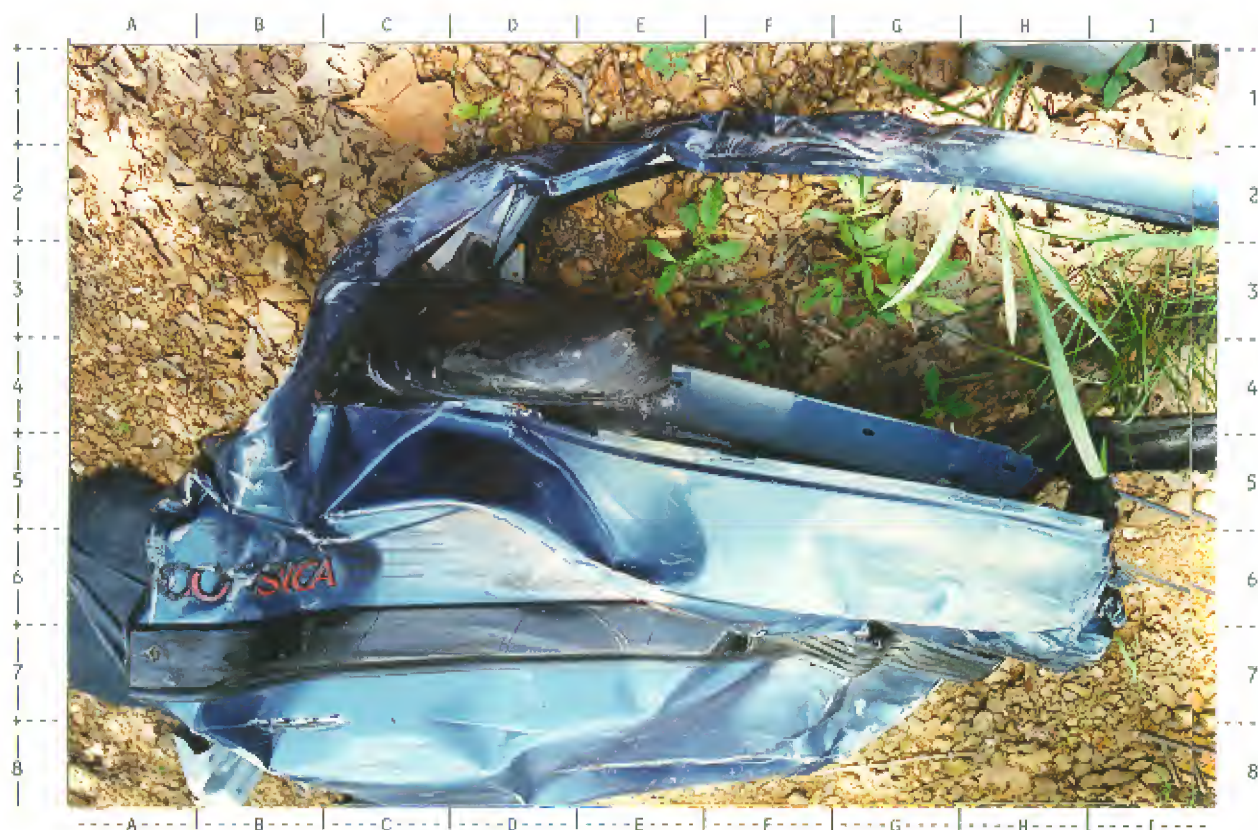
48 -- Damage to LF (driver's) door of 1991 Chevrolet; NOTE: red paint (1988 pickup's) transfer to top of window frame (cells G1--G2)

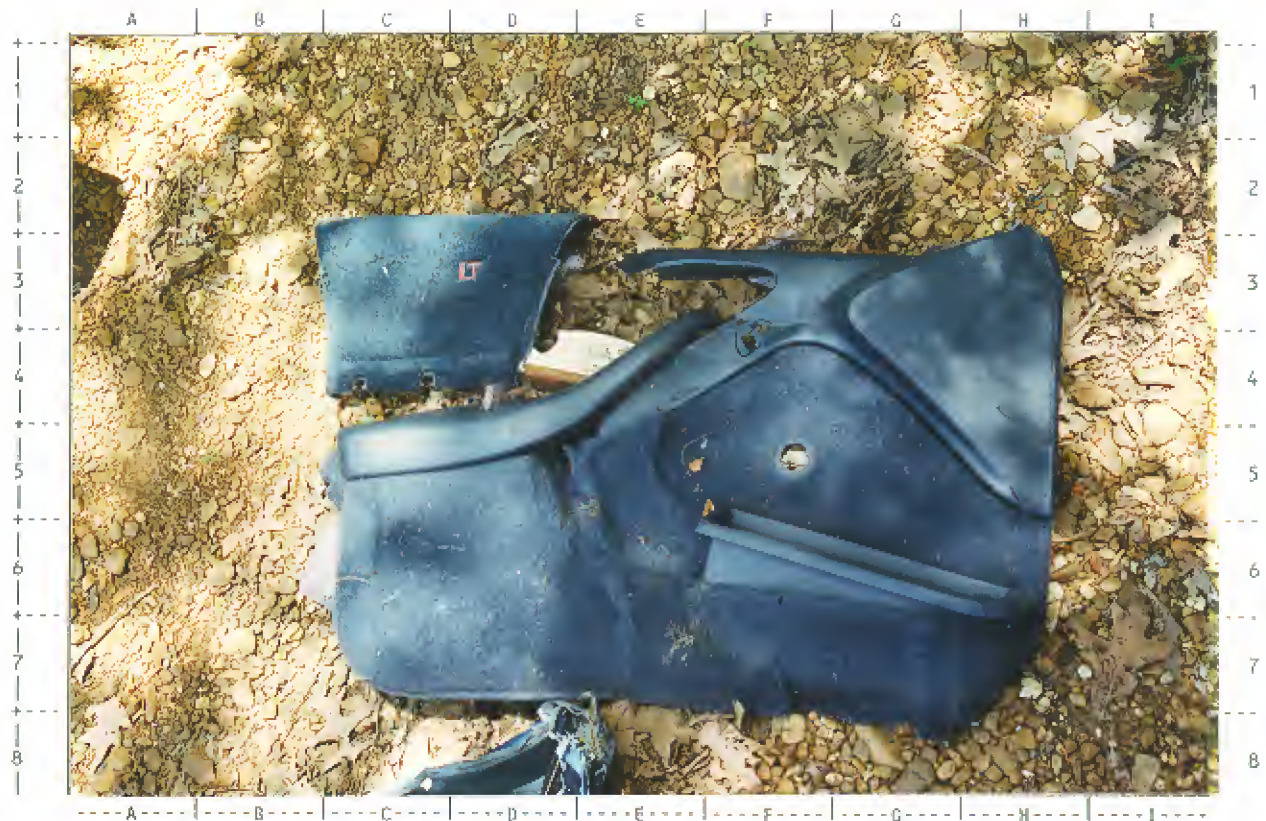
49 -- View of interior of 1991 Chevrolet Corsica's left front door;
NOTE: no evidence of contact is visible

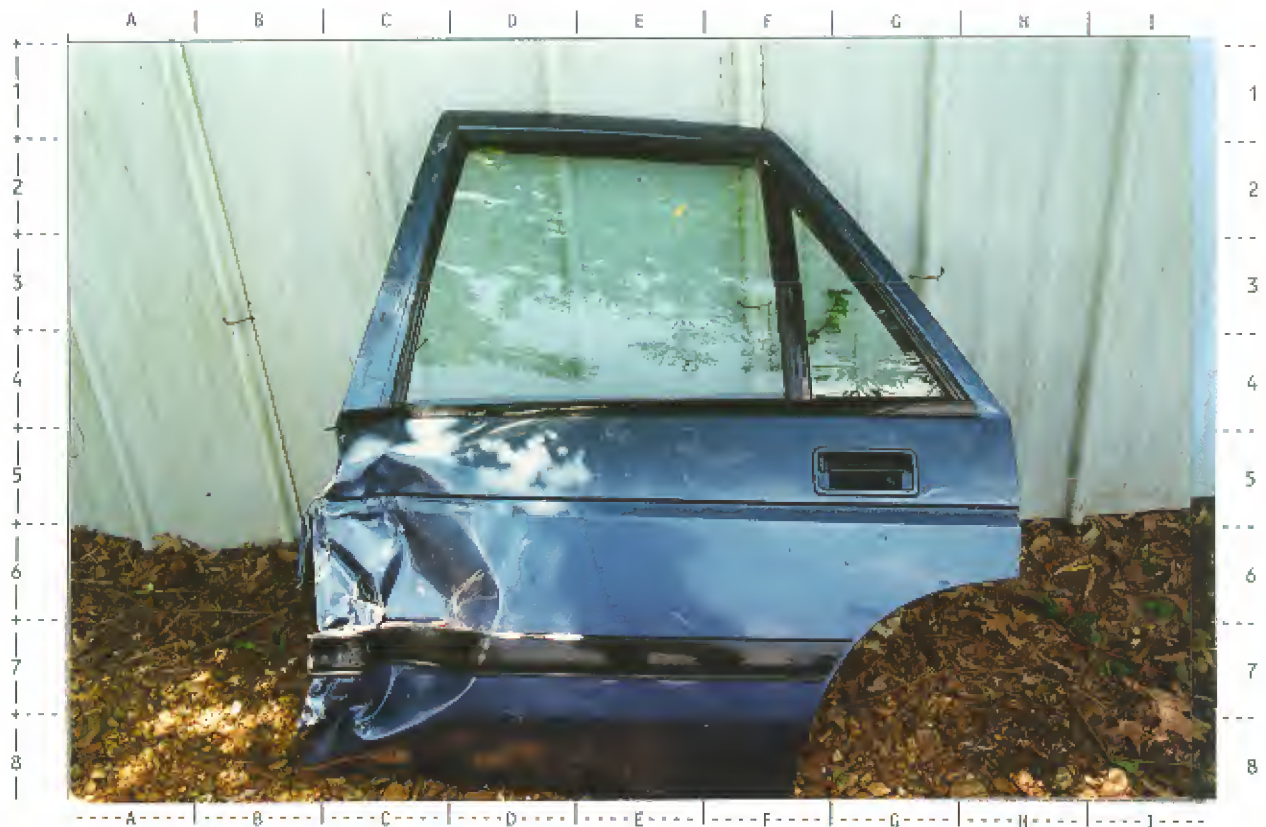
50 -- Damage to left rear door of 1991 Chevrolet Corsica; NOTE: door
was removed during extraction process

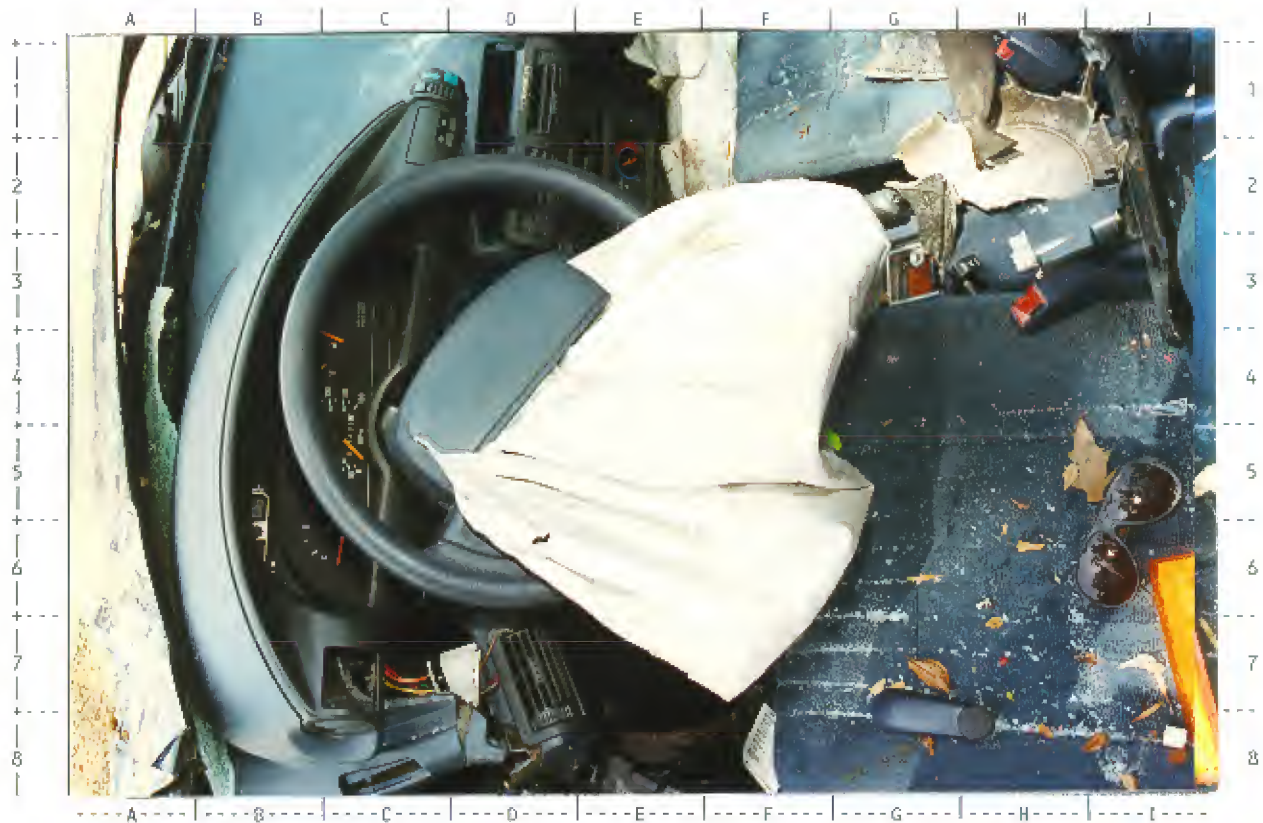
53 -- Overhead back left view of 1991 Chevrolet Corsica's driver seating area; NOTE: damage to air vent on left side of dash

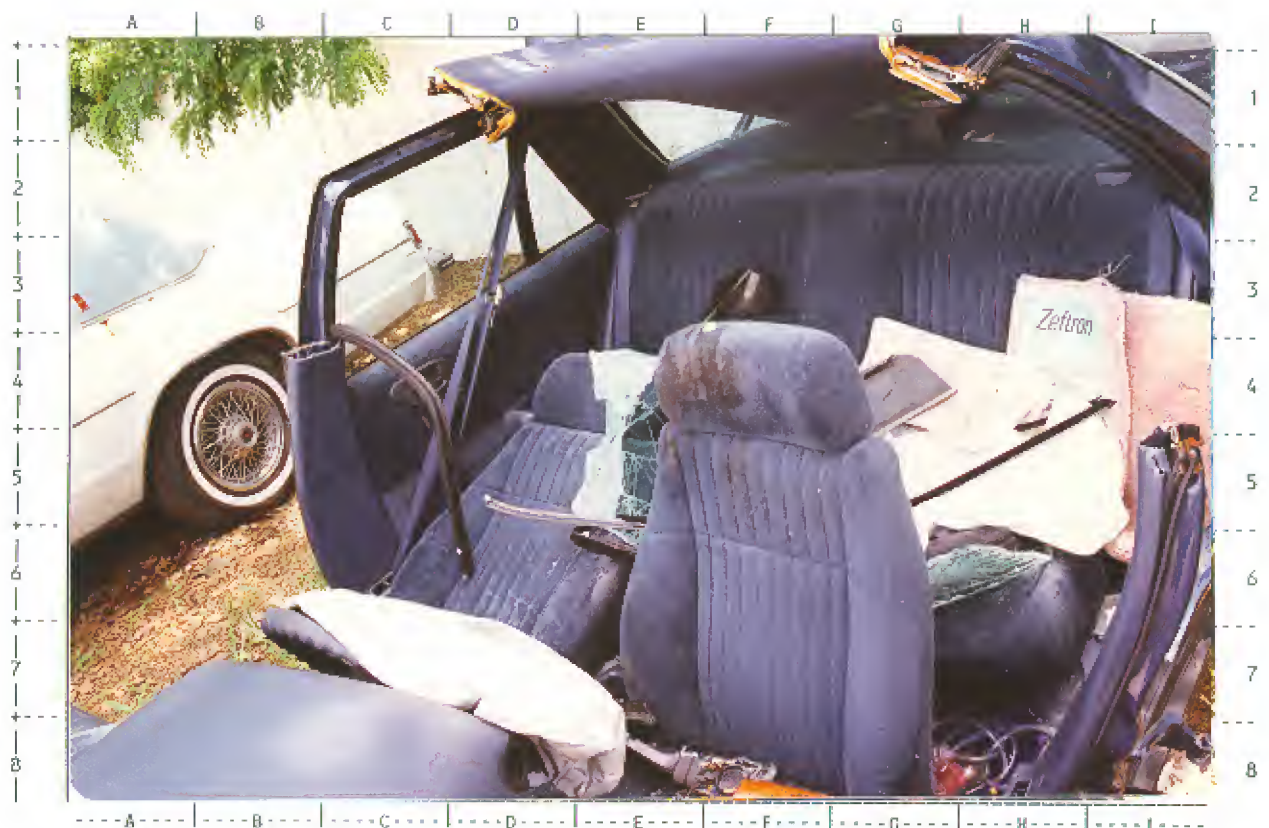
58 -- Overhead left front view of blood stained left front (driver's) seat of 1991 Chevrolet Corsica; NOTE: cut left B-pillar

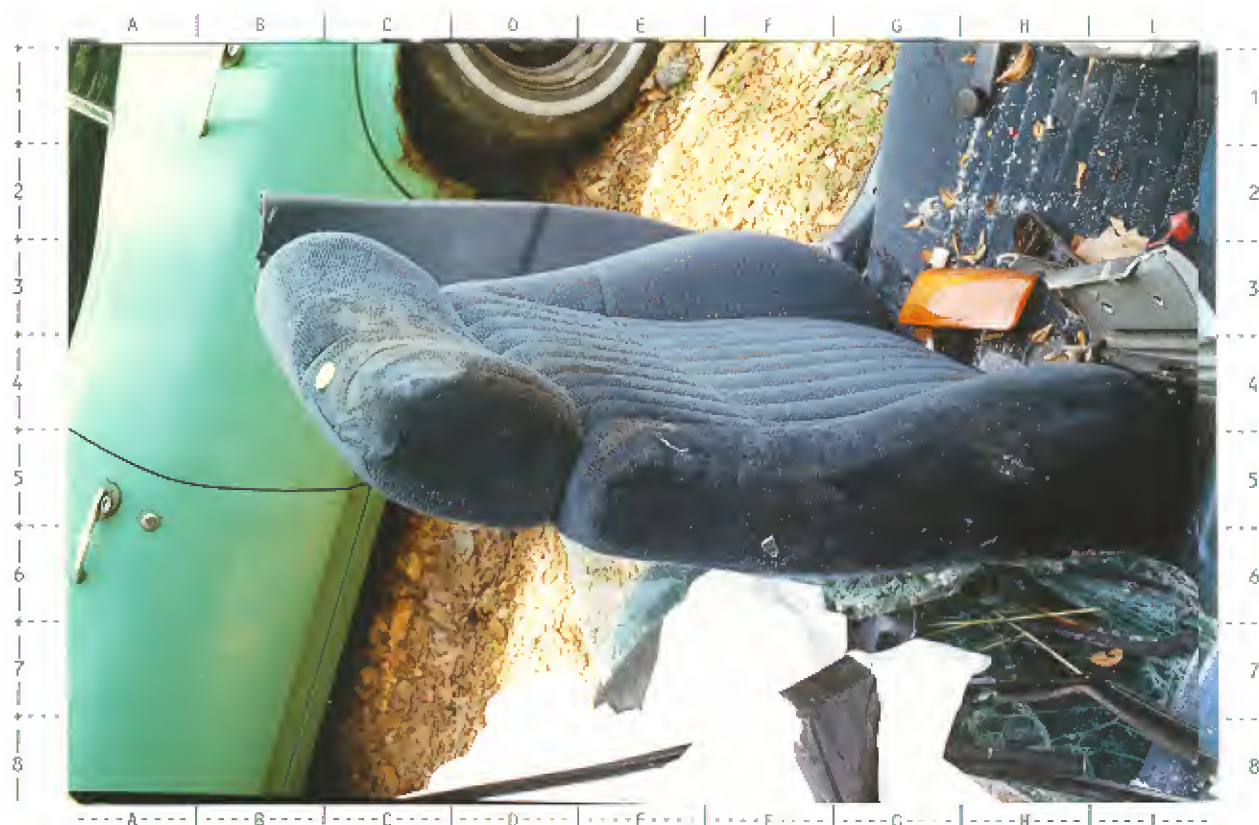
59 -- View from RF seat of 1991 Chevrolet Corsica's blood stained LF seat; NOTE: R side seat marks occurred most likely post-crash

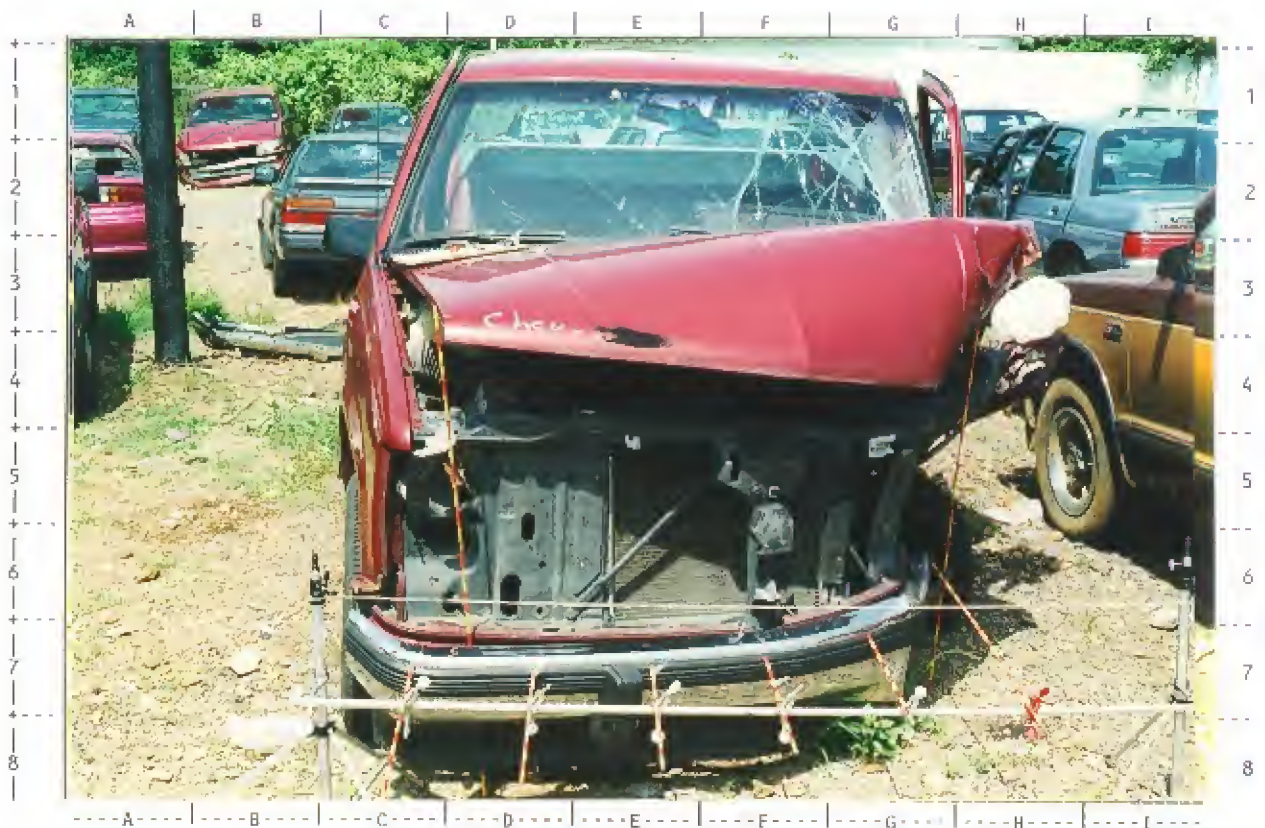
62 -- Frontal view of 1988 Chevrolet C-1500 pickup's front left damage with contour gauge present

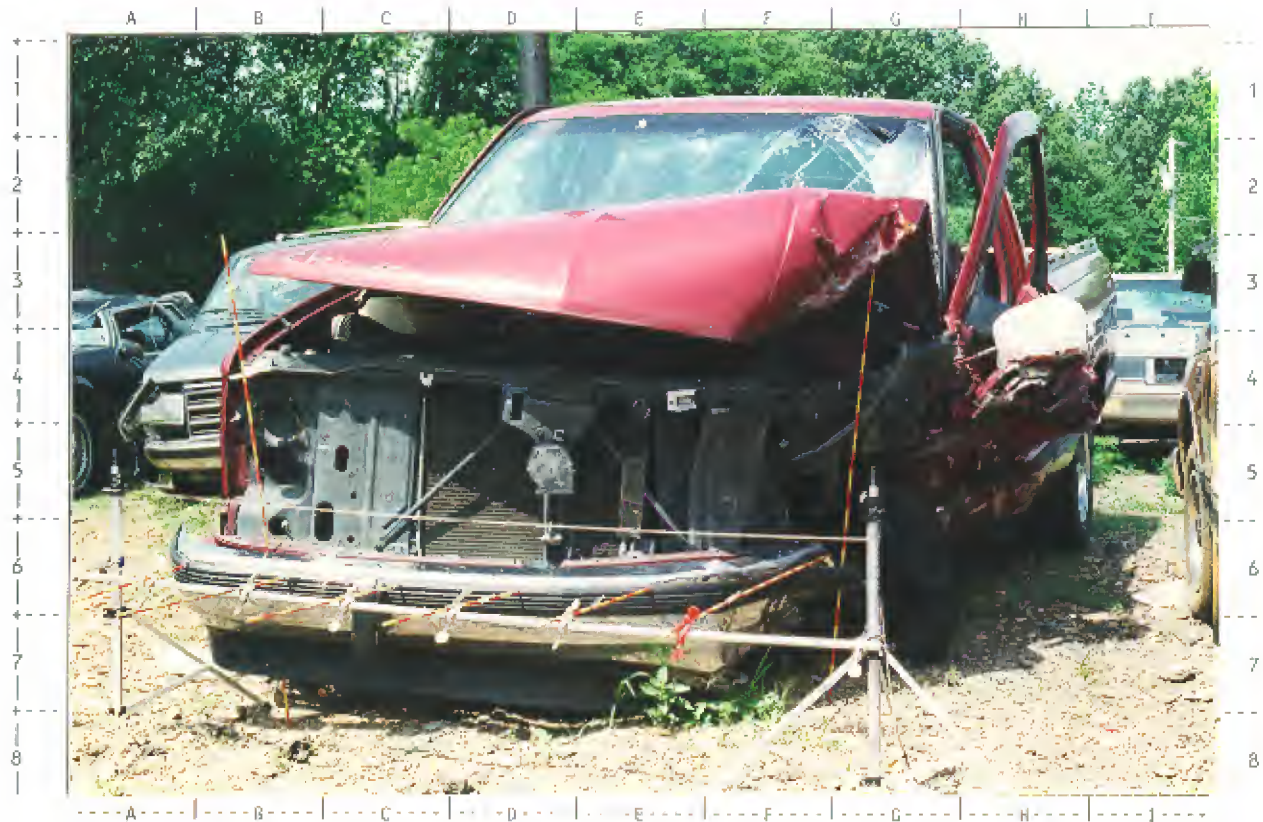
63 -- Front left view of '88 Chevrolet pickup's front left damage with contour gauge present; NOTE: FL hood damage and vertical rod

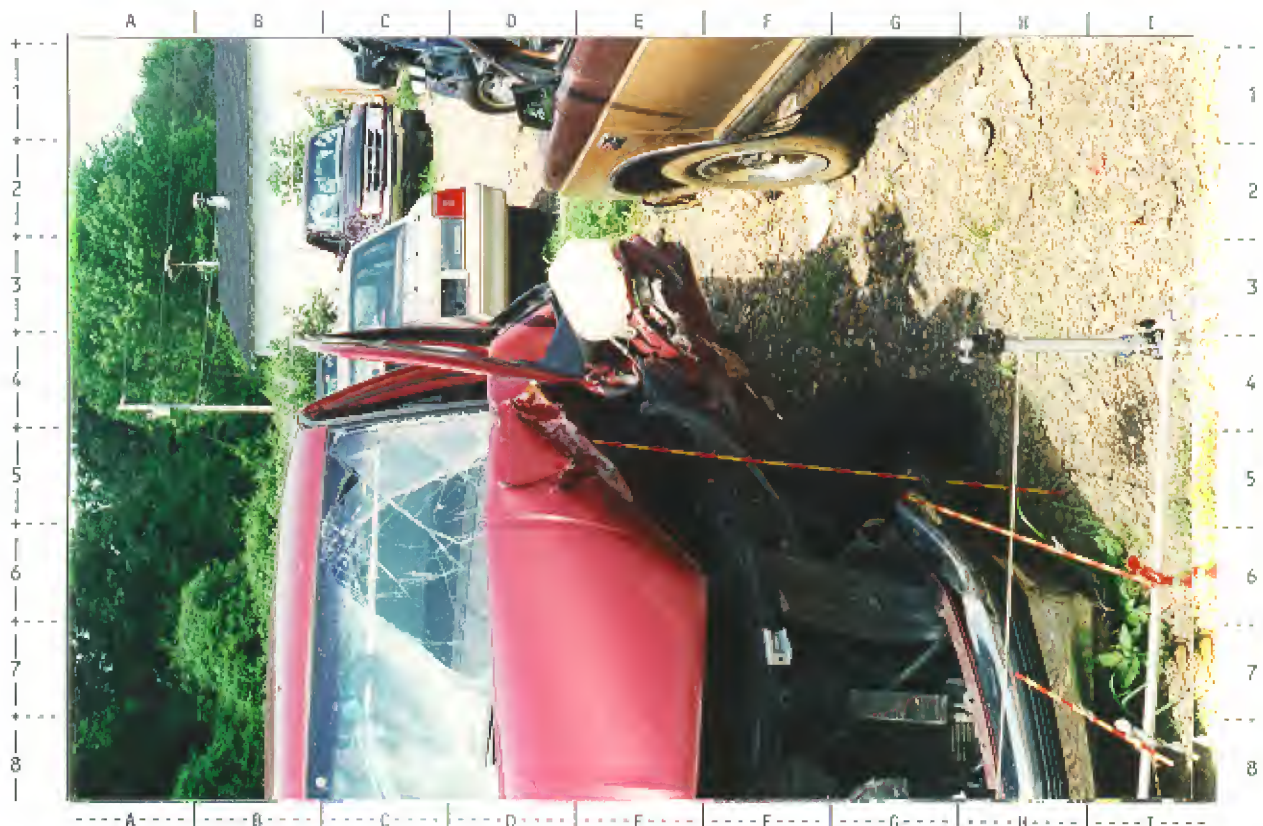
64 -- Left front reference line view showing frontal damage to 1988 Chevrolet C-1500 pickup; NOTE: vertical reference rod
